# Technical Service Notification

## Troubleshooting DPLLD Comm Alarms with Variable Frequency Controllers

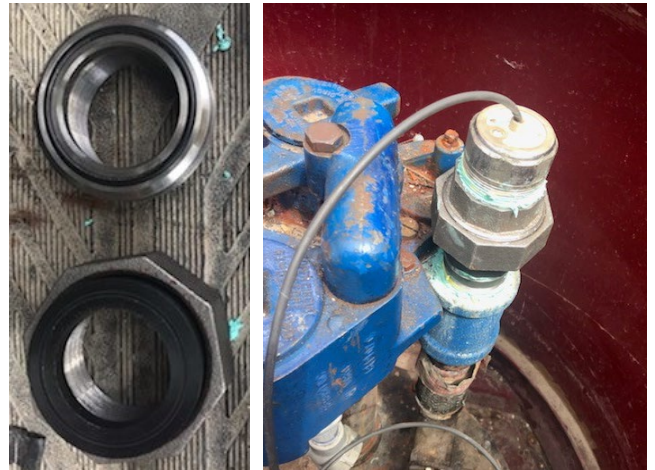
### Dielectric Union

Dielectric unions help isolate the transducer from the STP and can reduce or eliminate DPLLD comm alarms. Dielectric unions can be found at plumbing supply stores.
