TLS-450PLUS Console

Troubleshooting Guide

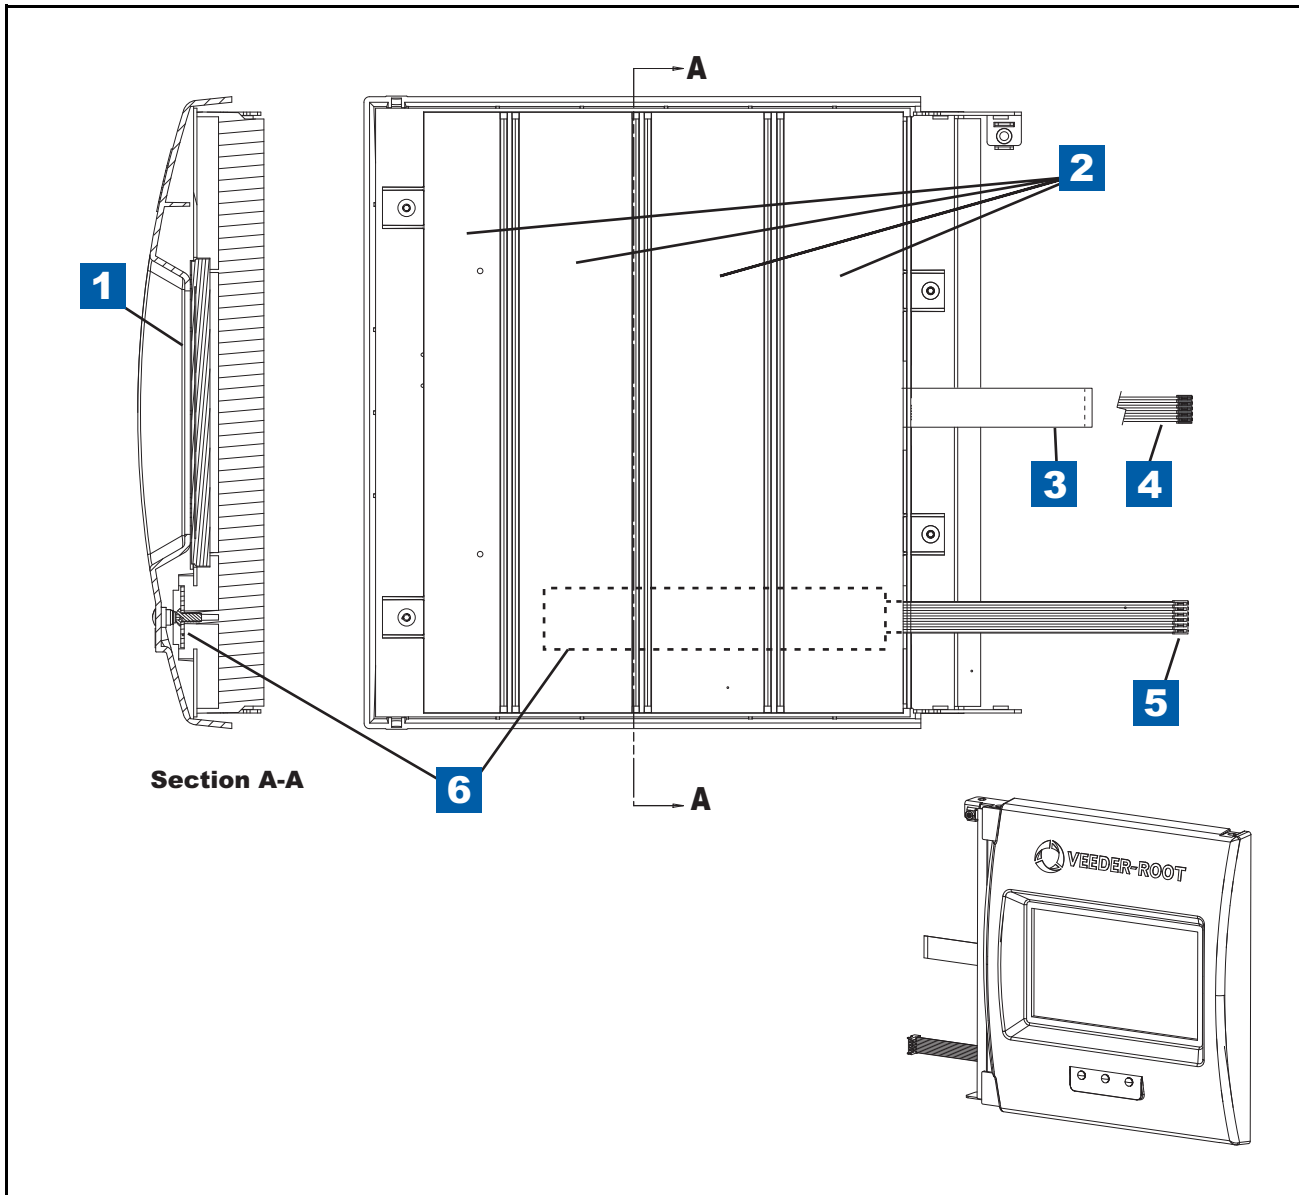
Figure 2-3. Display Door Assembly

Legend For Figure 2-3			
Item	Description	Item	Description
1	Touch screen display assembly	4	Cable to Ack Switch Panel connector on CPU board (item 16 in Figure 2-11)
2	Input Module Connection Labels	5	Cable to LED Backlight connector on CPU board (item 11 in Figure 2-11)
3	Cable to Data Display connector on CPU board (item 6 in Figure 2-11). Data Display is an option.	6	Front panel system status LED board assembly

Symptom	Cause	Corrective Action
Display Dark After Boot-Up	Bad Display cable, loose Display cable.	<p>1. Open the printer door.</p> <p>2. Verify the Display ribbon cable (Item 3 in Figure 2-3 on page 2-3) is securely seated in its CPU board connector and that the locking latch (1 pointer) is down against the cable. If inserted fully, the blue end of the cable will be no more than 1/16" (2mm) out of the connector as shown below:</p>

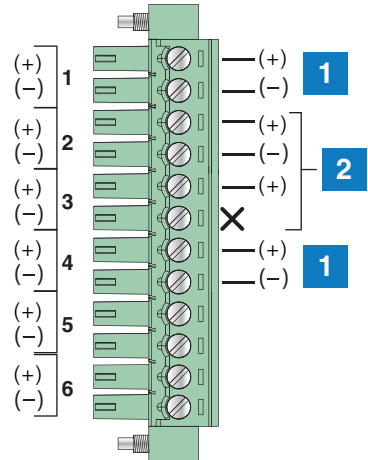
Symptom	Cause	Corrective Action
Sensor Connected To TLS-450PLUS But No Sensor Address Under Devices Menu	Sensor wires were connected while the console was ON.	Re-boot console.
	Sensor wiring installed incorrectly.	<p>1. Open the Display door.</p> <p>2. Polarity may be required for this device. Locate the questionable sensor's input wiring connections at the USM connector.</p> <p>If polarity required, verify the two wires are connected with white to + terminal and black to – terminal. (item 1 in diagram below)</p> <p>If three wire sensor, verify the three wires are connected as shown below (item 2 in diagram below):</p>

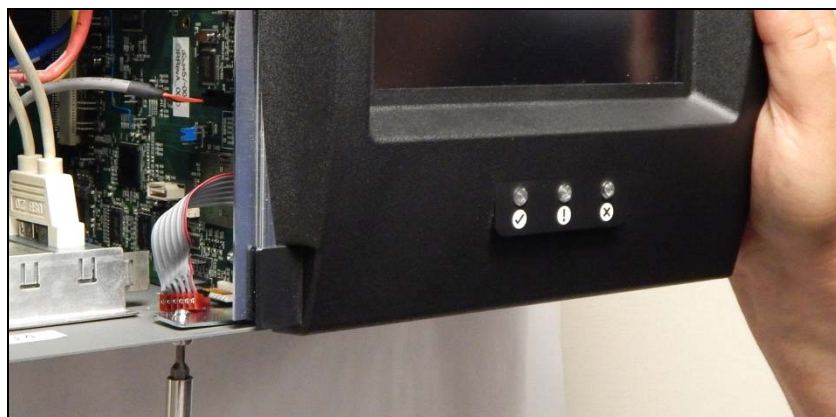
Figure 7-5. Remove Top And Bottom Optional Display Door Hinge Screws

5. Remove the TLS-450PLUS Ack Switch Panel/Display door by removing the top and bottom hinge shoulder screws (see Figure 7-5).

6. Remove the TLS-450PLUS Printer door by removing the top and bottom hinge shoulder T15 screws (similar to the Ack Switch Panel/Display Door shoulder screws Figure 7-5).

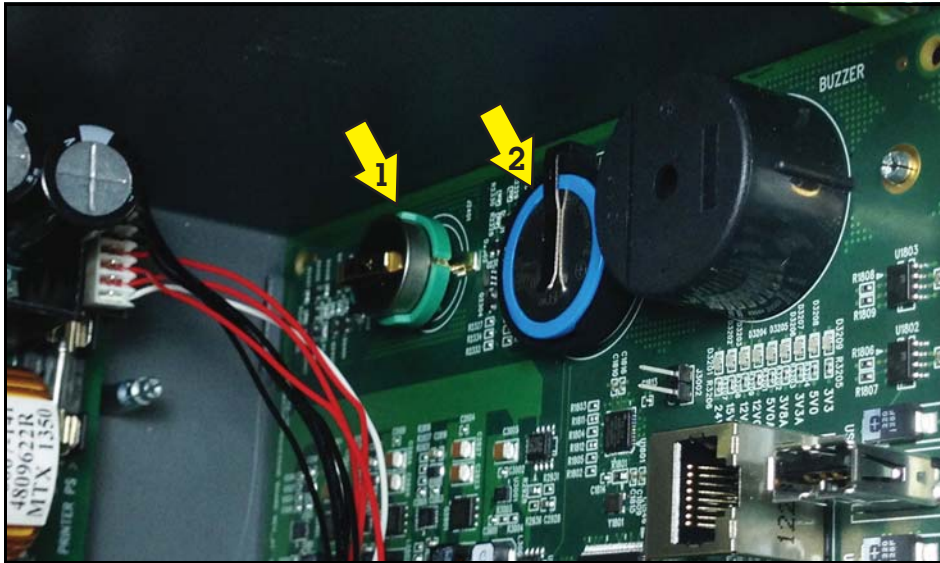
Figure 7-14. Locating Features iButton And Backup Battery

1. Perform all of the Steps in the section entitled "Before Turning Off Power" on page 7-2.
2. Open the right and left console doors as described in Step 1 of the section entitled "Removing The Ack Switch Panel/Display (Right) Door And CPU Board" on page 7-3.
3. Locate the backup battery at the top of the CPU board (see pointer 2 in Figure 7-14).

Legend For Figure 7-14			
Item	Description	Item	Description
1	Features iButton	2	Backup Battery

4. Holding the CPU board by its edges, place it on a clean surface. Locate the Features iButton at the top of the CPU board (see pointer 1 in Figure 7-14).
5. Remove the iButton by gently lifting the retaining clip over the iButton as you slide it out of its holder.
6. When inserting the iButton make sure the flanged side is up as it is slid into its holder:

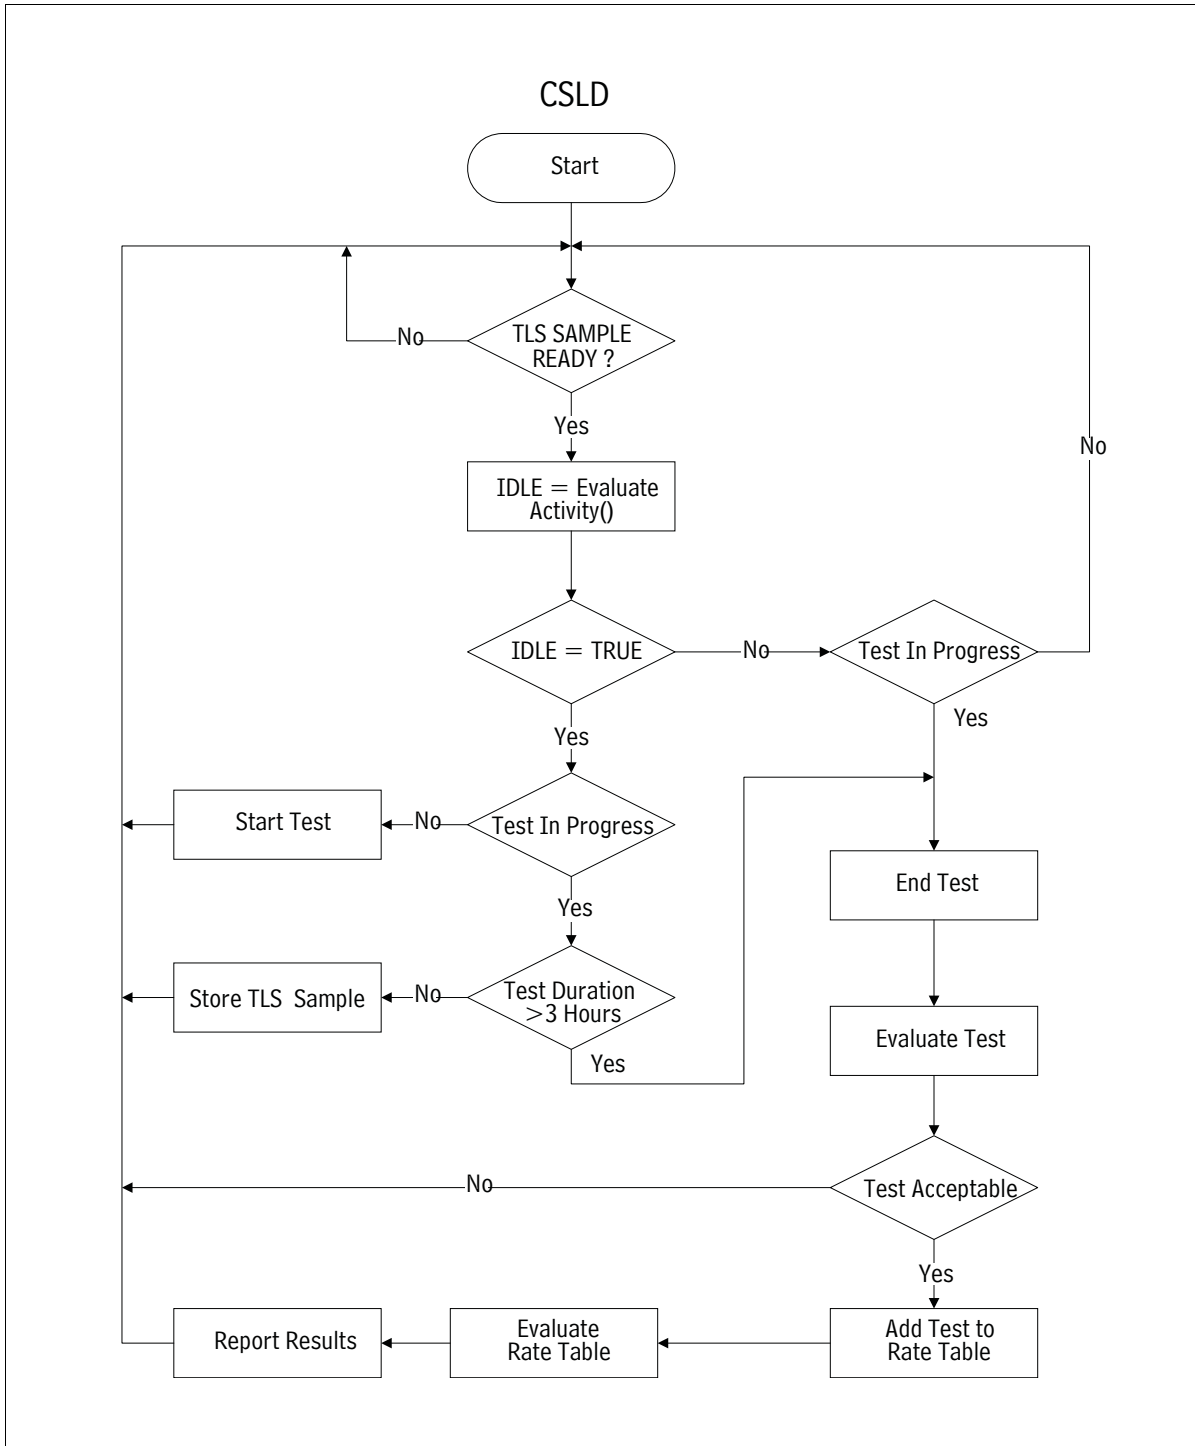
Figure 11-1. CSLD Decision Process Block Diagram

Figure 11-1 illustrates the CSLD decision process in block diagram form and Figure 11-2 diagrams the timing of events during a CSLD test.
